WINNICUT DAM REMOVAL FEASIBILITY STUDY

DAM INSPECTION REPORT

Subject: Inspection of Winnicut Dam, NATDAM#: NH00040

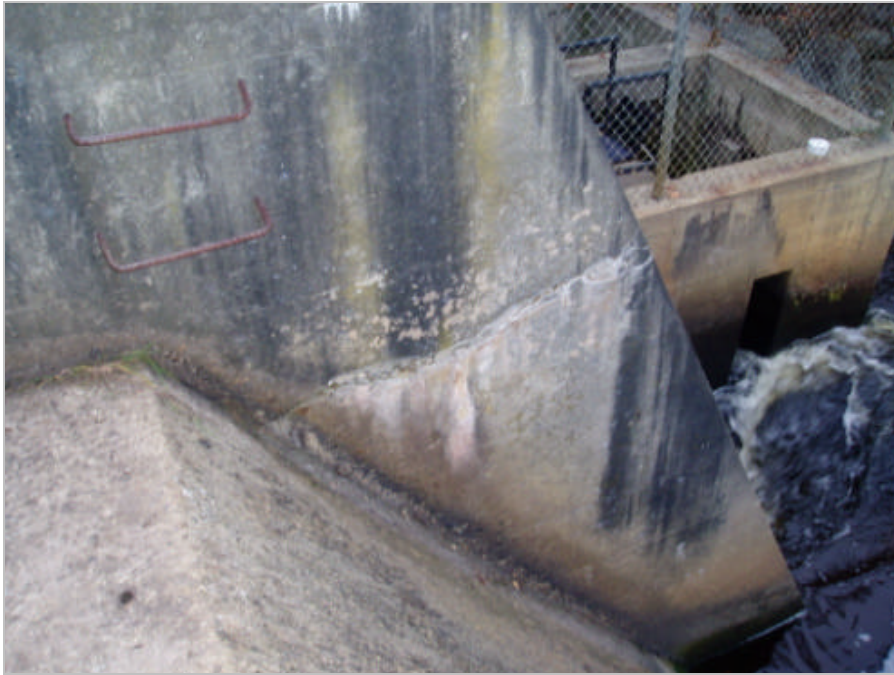
- 1) Thick brush was present adjacent to the downstream portion of the left abutment and fishpass, precluding a thorough inspection of the dam and fishpass structure in this area (Photo 1).
- 2) A horizontal crack is present on the right pier of the stoplog bay (left spillway training wall [Photo 2]).
- 3) This crack is noted in previous inspection reports.
- 4) There is a small area (less than 2 square feet) of surface spalling on the face of the right abutment [Photo 3]). The spalling is noted in previous inspection reports.
- 5) Undermining of the fishpass foundation was observed immediately downstream of the stoplog bay.

Photo 1 Winnicut Dam from right abutment (note vegetation encroaching on the left abutment adjacent to the fishpass).

- 1) Remove brush within 10 feet of the dam and fishpass structure.
- 2) Monitor and repair the crack on the right pier of the stoplog bay (left spillway training wall).

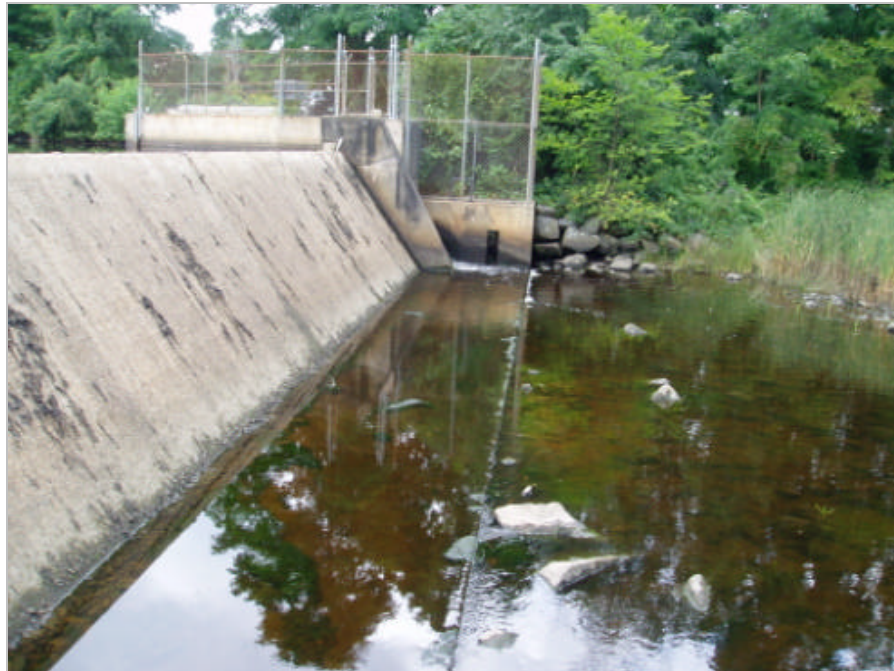
Photo 2 Crack in concrete on left spillway training wall.

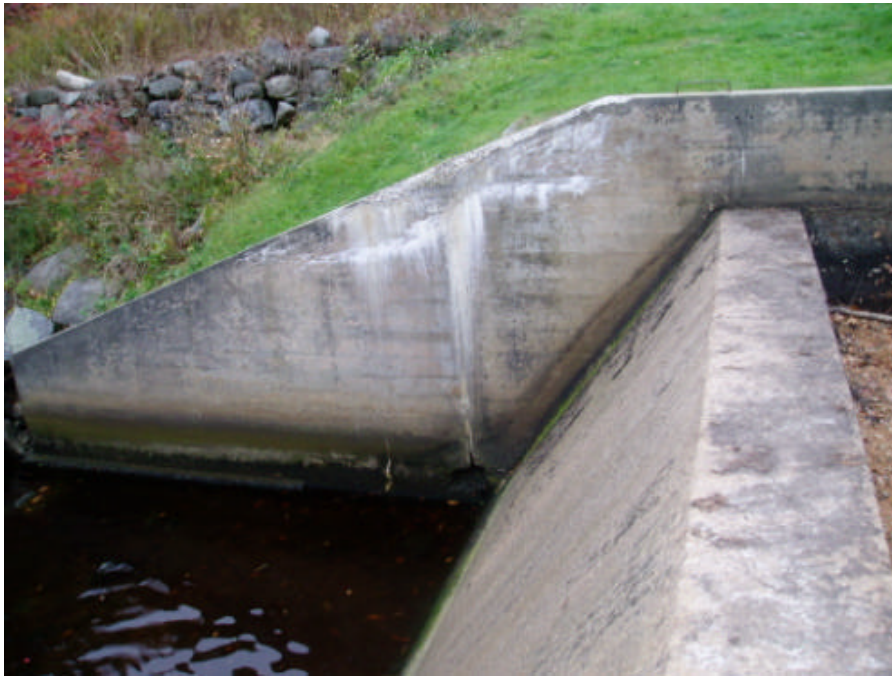
Photo 3 Spalling concrete on the face of the right abutment.

- 3) Monitor and repair (as necessary) the spalling on the face of the right abutment.
- 4) The undermining of the fishpass foundation downstream of the stoplog bay should be addressed through the placement of suitable scour countermeasures in this area. Because of the potential for very high flow speeds in this area (i.e., > 20 feet-per-second), rock riprap may not provide a long-term countermeasure. It is therefore recommended that alternatives measures be evaluated, such as increasing the overall size of the concrete apron, installation of articulated concrete blocks downstream of the existing apron, or other suitable countermeasures.
